**PCB REMEDIAL ACTION COMPLETION REPORT  
COMMONWEALTH EDISON TRANSFORMER RELEASE  
ST. THOMAS THE APOSTLE SCHOOL  
453 PIERSON STREET  
CRYSTAL LAKE, ILLINOIS**

**September 30, 2009**

**Enginex Project No. 8131**

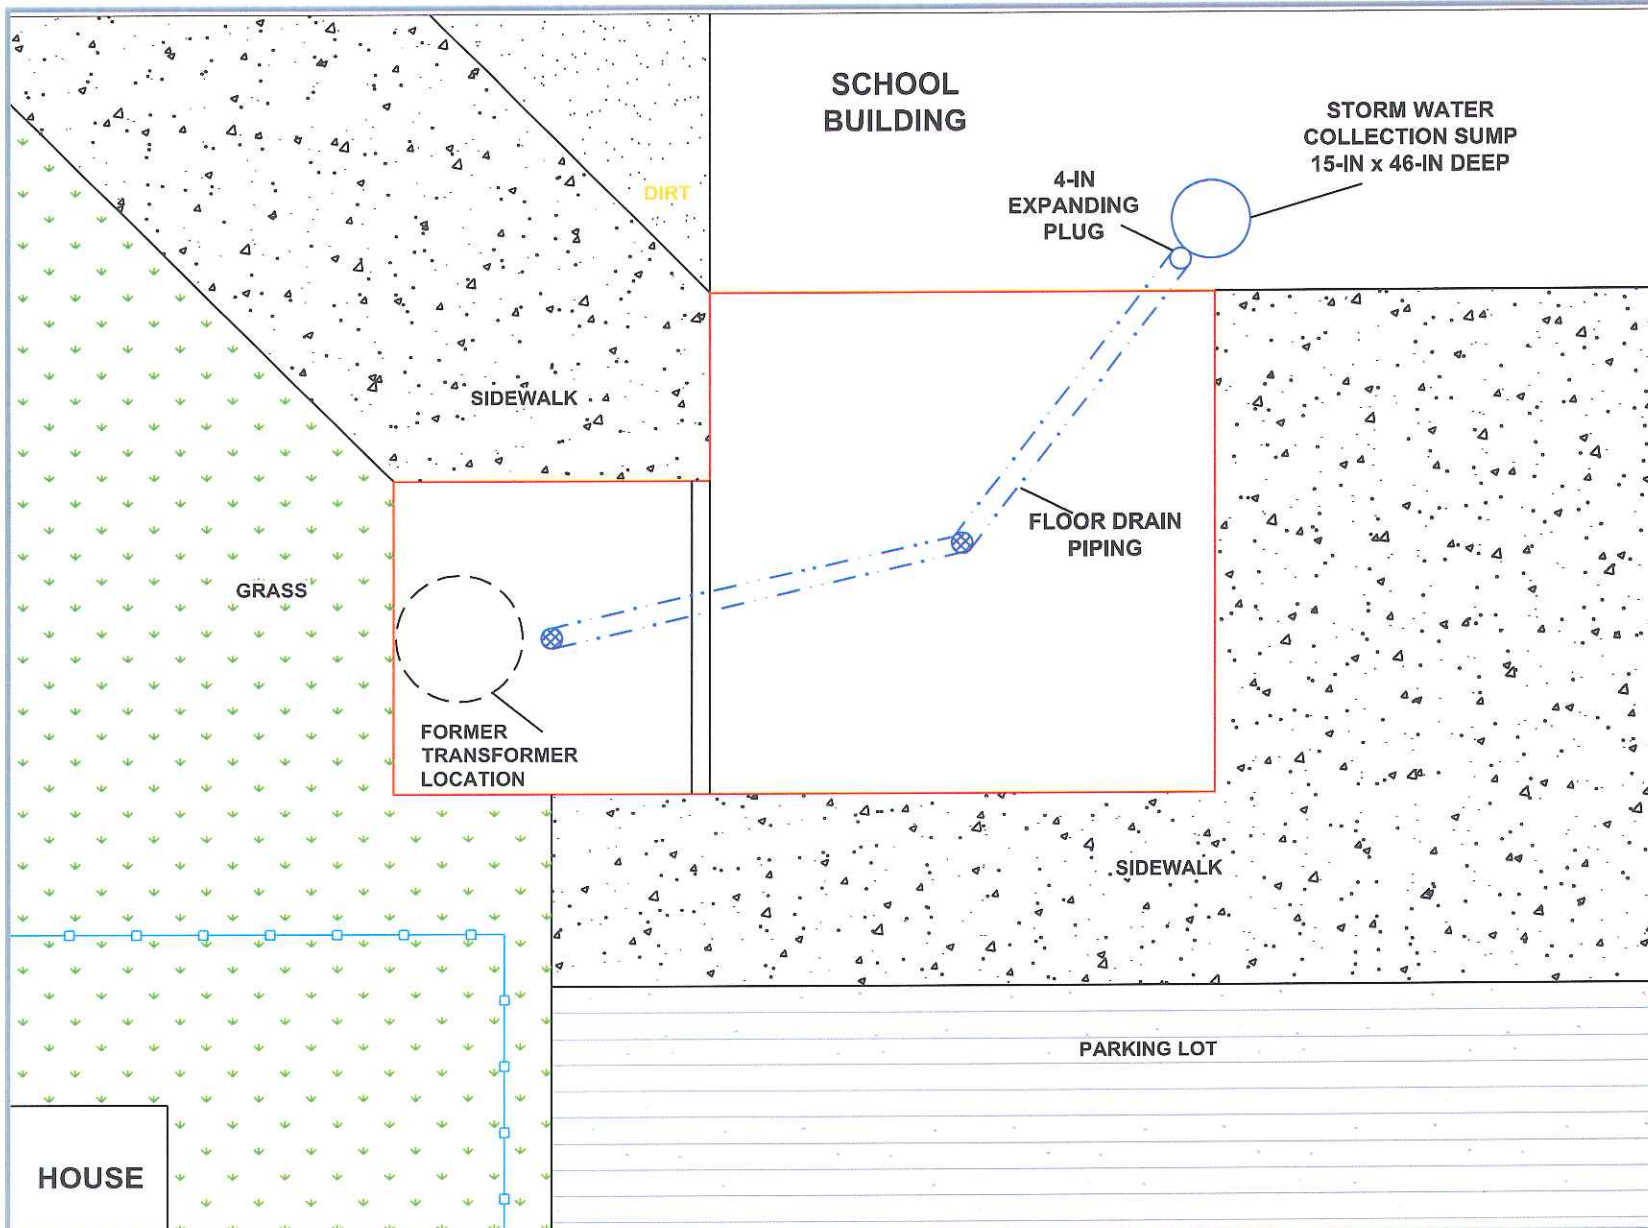
FIGURE 3  
SITE LAYOUT MAP

4-IN DRAIN PIPE

FLOOR DRAIN

BELOW GRADE  
TRANSFORMER  
VAULT

The removal of the concrete floor represented a conservative approach by ComEd to address the presence of residual PCB concentrations measured in wipe samples collected during the initial response activities. The concrete floor removal was performed between August 17 and 19, 2009. SET Environmental, Inc. (SET) located in Wheeling, IL performed the removal of the concrete floor. As previously discussed, the dimensions of the eastern section of the vault area were approximately 8 ft by 8 ft, while the dimensions of the western section of the vault area were approximately 5 ft by 5 ft. Figure 3 shows the layout of the electrical vault area and relevant site features around it.

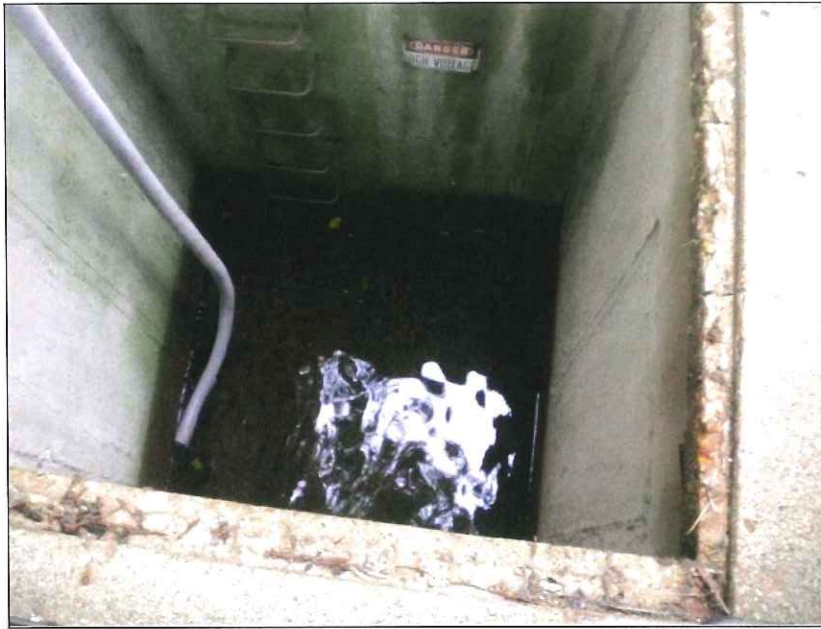
**Photo 1:** Vacuuming of accumulated rain water from western section of electrical vault prior to beginning the concrete removal.

Prior to beginning the concrete removal, rain water that had accumulated within the smaller, western section of the vault had to be removed. A vacuum unit and hose was used to transfer the accumulated water into two 55-gallon drums for off-site disposal. SET workers were then able to enter the vault to begin the concrete removal. Workers inside of the vault during the concrete removal wore Level C protection, which included a full-face respirator fitted with particulate cartridges. Confined space entry protocol was followed. An air compressor and duct hosing was used to place a negative air pressure on the vault area for purposes of dust control.

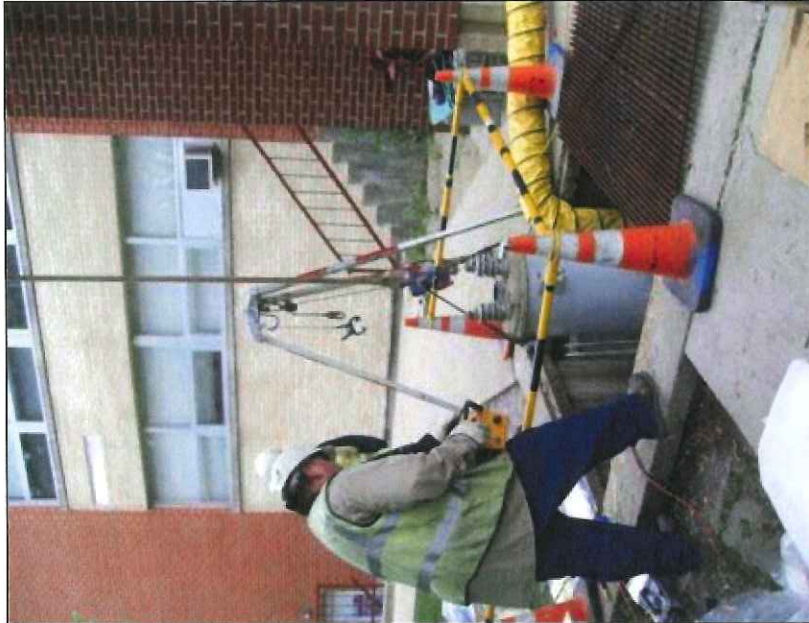
**Photo 2:** Confined space entry procedures used during concrete removal.

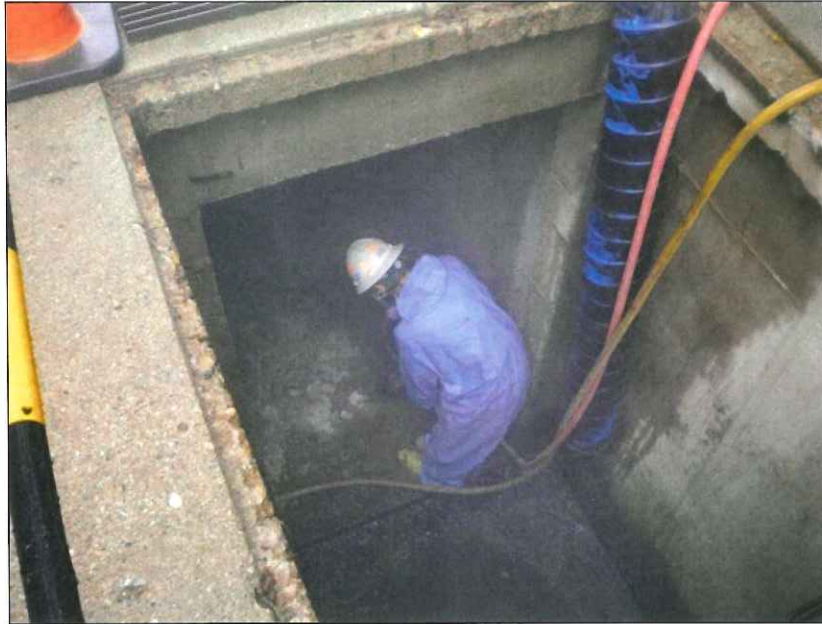
**Photo 3:** Jack-hammering of concrete floor into small pieces for removal from electrical vault. Also shows air duct hosing used for dust control.

Jack-hammers were used to break up the concrete floor into small pieces to facilitate removal from the electrical vault. The broken concrete pieces and gravel sub-base materials were manually shoveled into 5-gallon pails and removed from the vault using a hoist and then transferred into a Bobcat bucket attachment. Once full, the Bobcat transferred the removed materials into a lined roll-off box. A composite sample of the concrete was collected for waste disposal characterization at the time of the removal. The roll-off box containing the removed concrete and gravel sub-base materials was transported for off-site landfilling at a TSCA-permitted facility (i.e., PCB levels > 50 ppm).

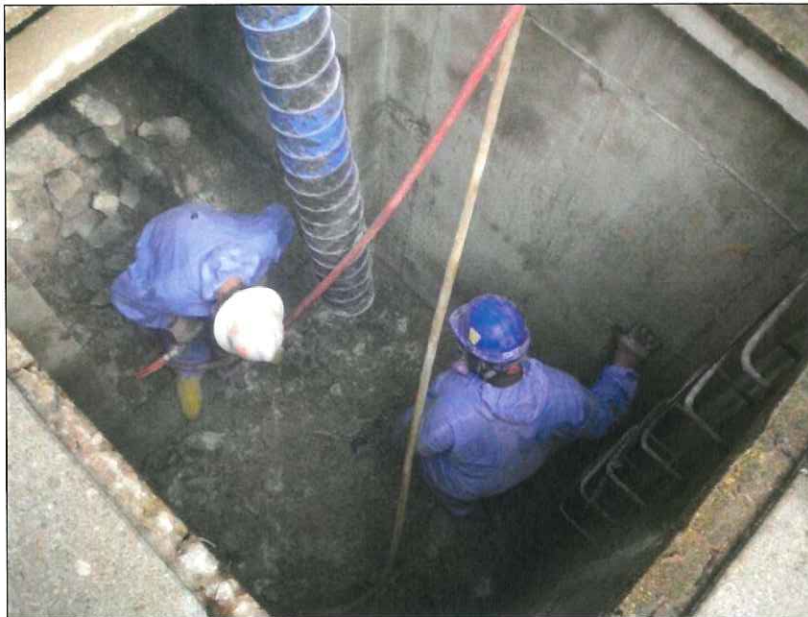
**Photo 4:** Jack-hammering of concrete floor into small pieces for removal from electrical vault.

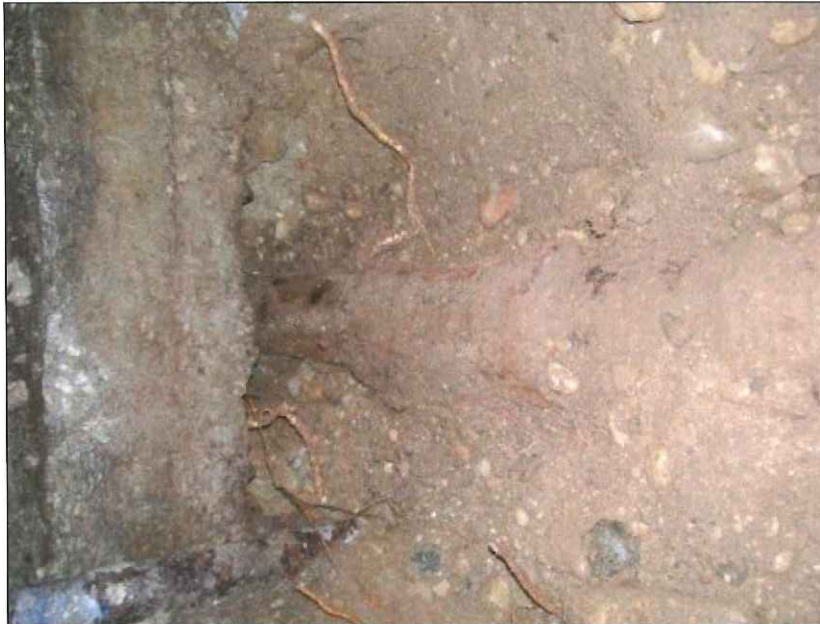
**Photo 5:** Drain pipe entrance point into school's mechanical room sleeved through shared wall.

vault area were also to be removed. The floor drain piping was to be cut and sealed with concrete just prior to where it is sleeved through the adjoining foundation wall to the school's mechanical room leading to the sump. Following completion of planned soil confirmation sampling and any removal, the vault cavity was to be backfilled to grade with CA6 stone and permanently closed.

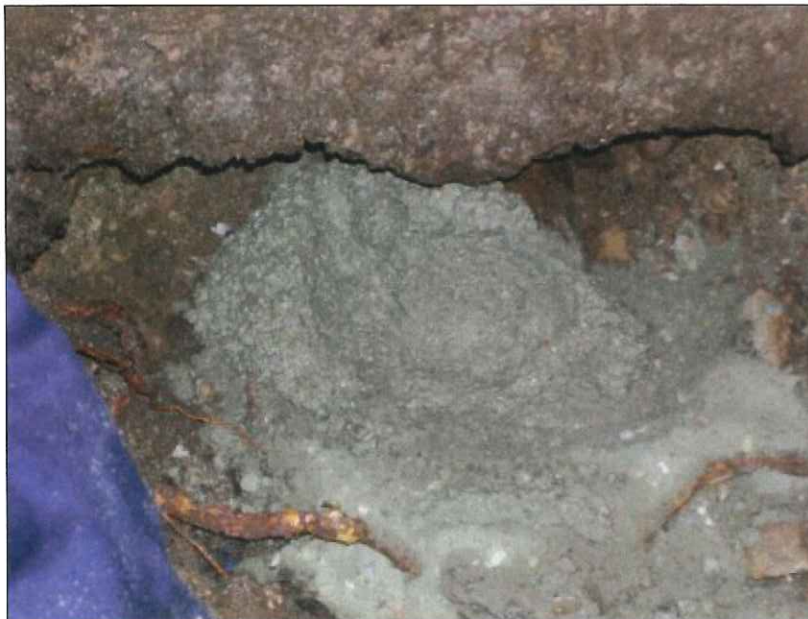
**Photo 6:** Drain pipe at entrance into mechanical room after being cut and end sealed/plugged with cement.

Once the concrete floor and gravel sub-base were removed, the drain pipe from the two vault sections was cut and removed up to the sleeved entrance through the adjoining wall into the mechanical room. The end of the drain pipe at the sleeved entrance to the mechanical room was then plugged/sealed using concrete. ComEd retained another contractor to break up and remove the concrete vault ceiling that had not been impacted with PCBs. Once the analytical results for the soil samples were received and showed no impacts above the PCB remediation objective (refer to Section 3.0), a Bobcat was used to backfill the vault cavity to grade with CA6 stone.

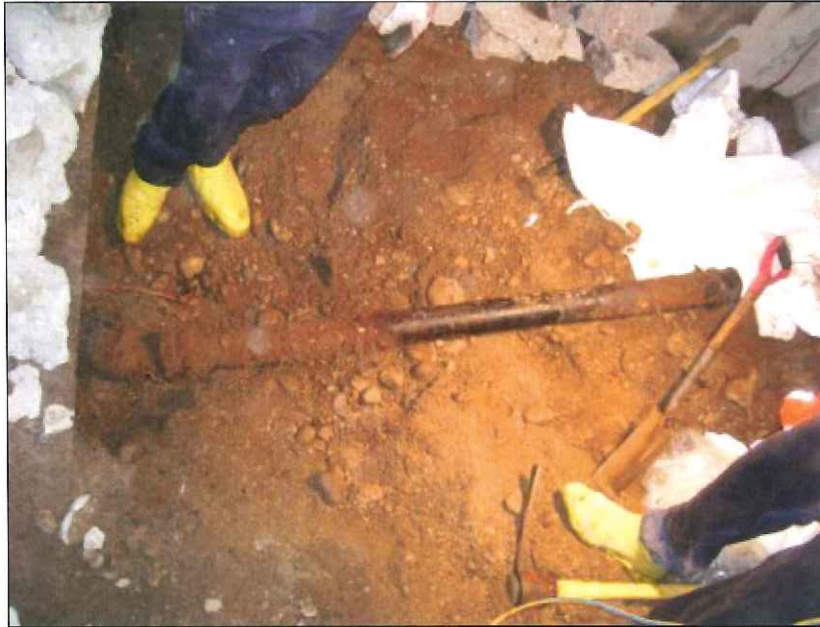
**Photo 7:** Floor of electrical vault after removal of concrete floor and gravel base.

Once the concrete floor and gravel sub-base had been removed, SET performed soil characterization sampling beneath the floor in accordance with Section 4.2 of the PCB Notification Plan/RAP. Discrete shallow soil samples were collected from beneath the floor on August 18, 2009 to determine if PCB impacts permeated through the concrete to the soil beneath it. A grid sampling protocol was performed on both sides of the electrical vault consistent with the site characterization sampling requirements contained in 40 CFR Part 761, Subpart N. The discrete soil samples were collected to a maximum depth of approximately three inches using a stainless steel scoop.

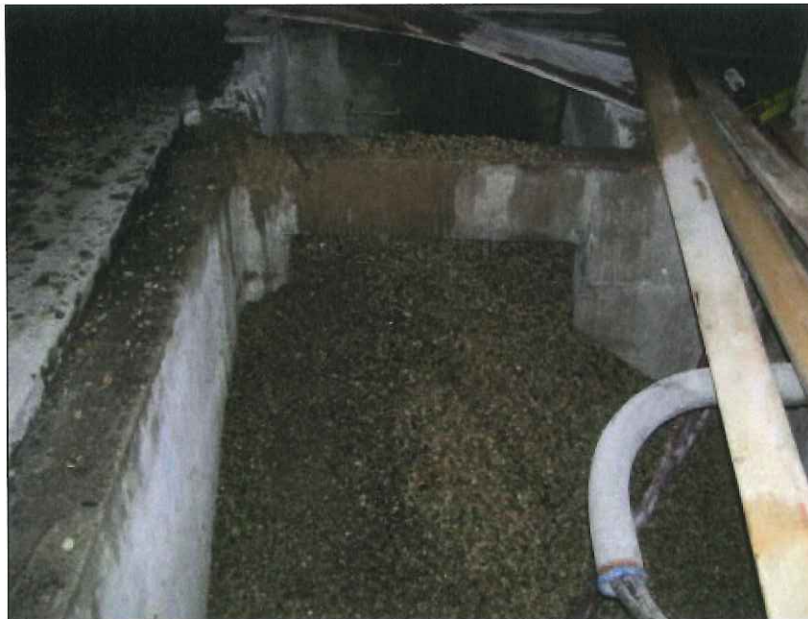
**Photo 8:** Backfilling of electrical vault cavity with CA6 stone for permanent closure.
